MISCELLANEOUS PAPER S-77-9

PRELIMINARY INVESTIGATION OF GENERAL-PURPOSE MAT/PANEL MATERIALS

Soils and Pavements Laboratory
U. S. Army Engineer Waterways Experiment Station
P. O. Box 631, Vicksburg, Miss. 39180

May 1977

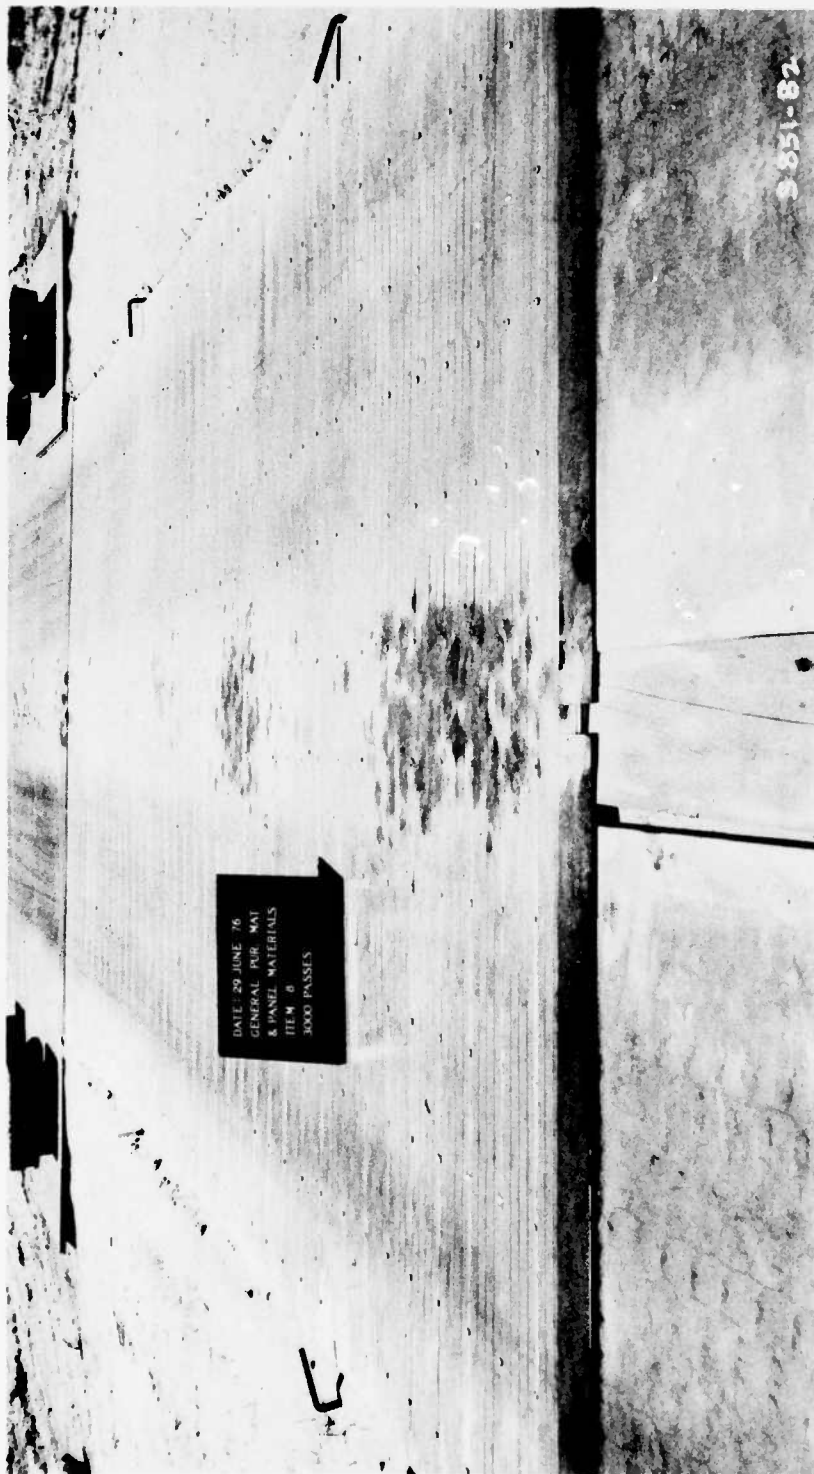
Photo 33. Alcoa panels at 3000 passes (end of traffic test); no failures

55. The Alcoa panels sustained 3000 passes of the test load truck without any breaks in the panels. The rivets wore and worked loose, but kept the panels secured together. The rivets are not considered a desirable way to connect the panels, but were used as an expedient to test the panels. The M8Al panels were the only panels tested that

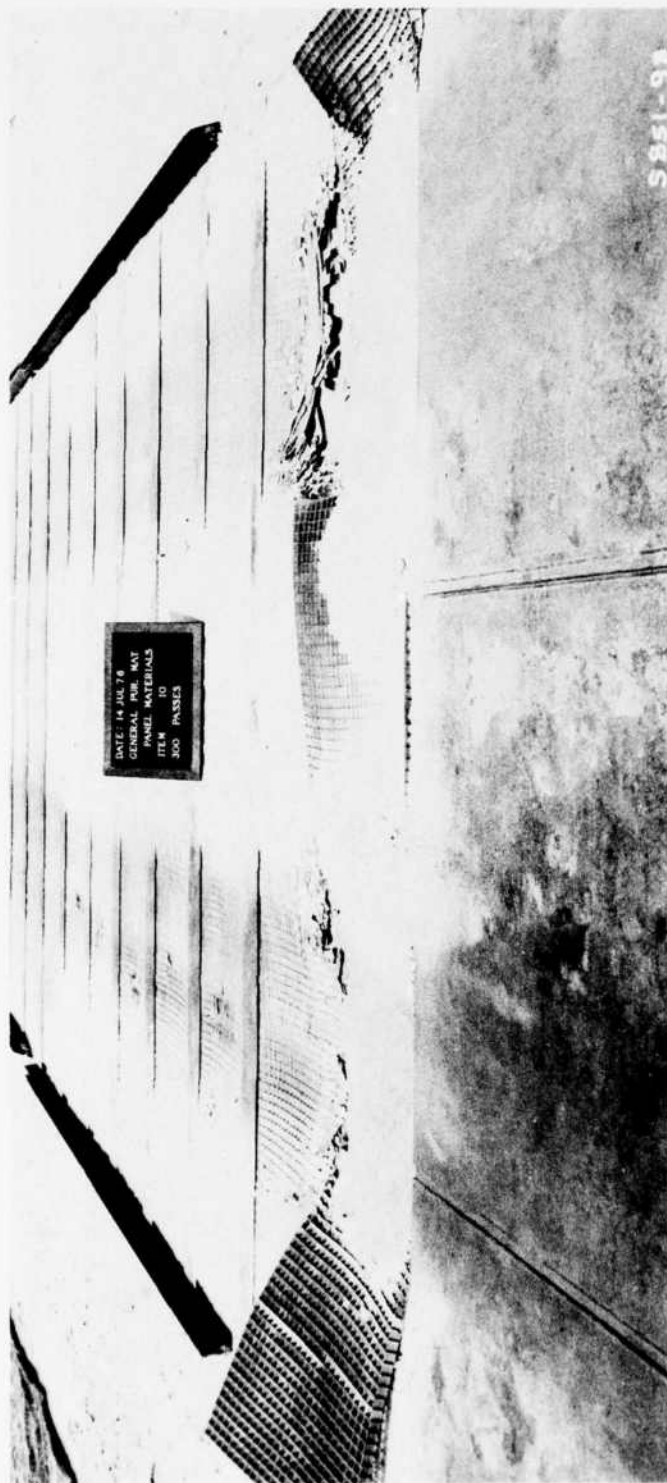
Photo 37. Failed Spur-Ecolite item 10 at 300 passes

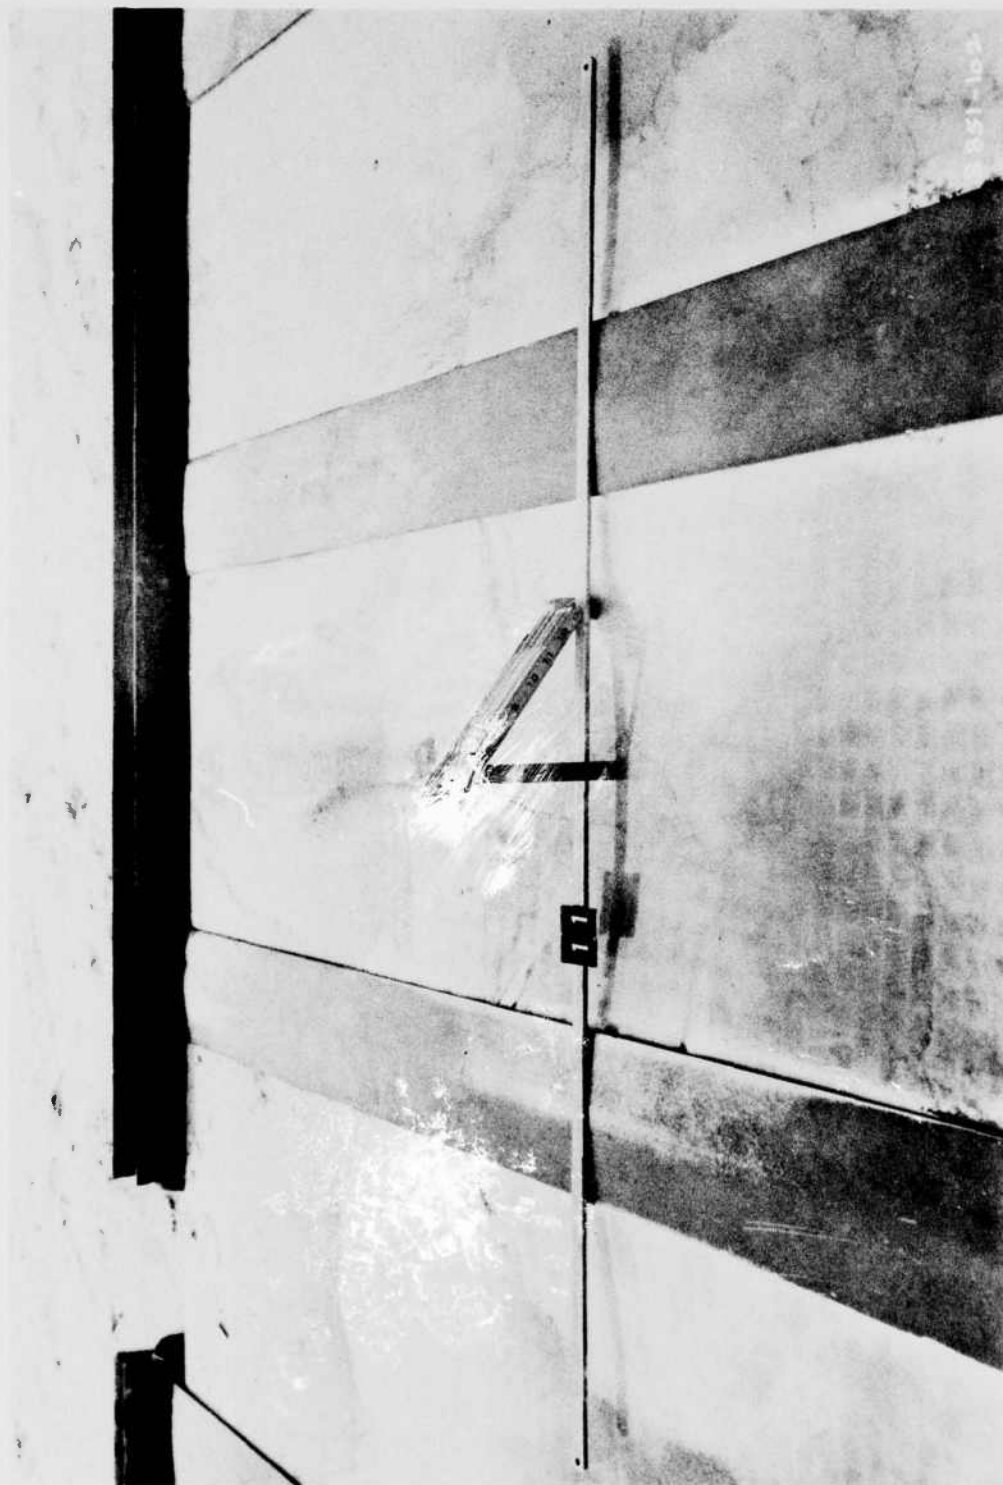
Photo 39. Transverse dishing of 1 in. on Spur-Ecolite sandwich panel at 200 passes

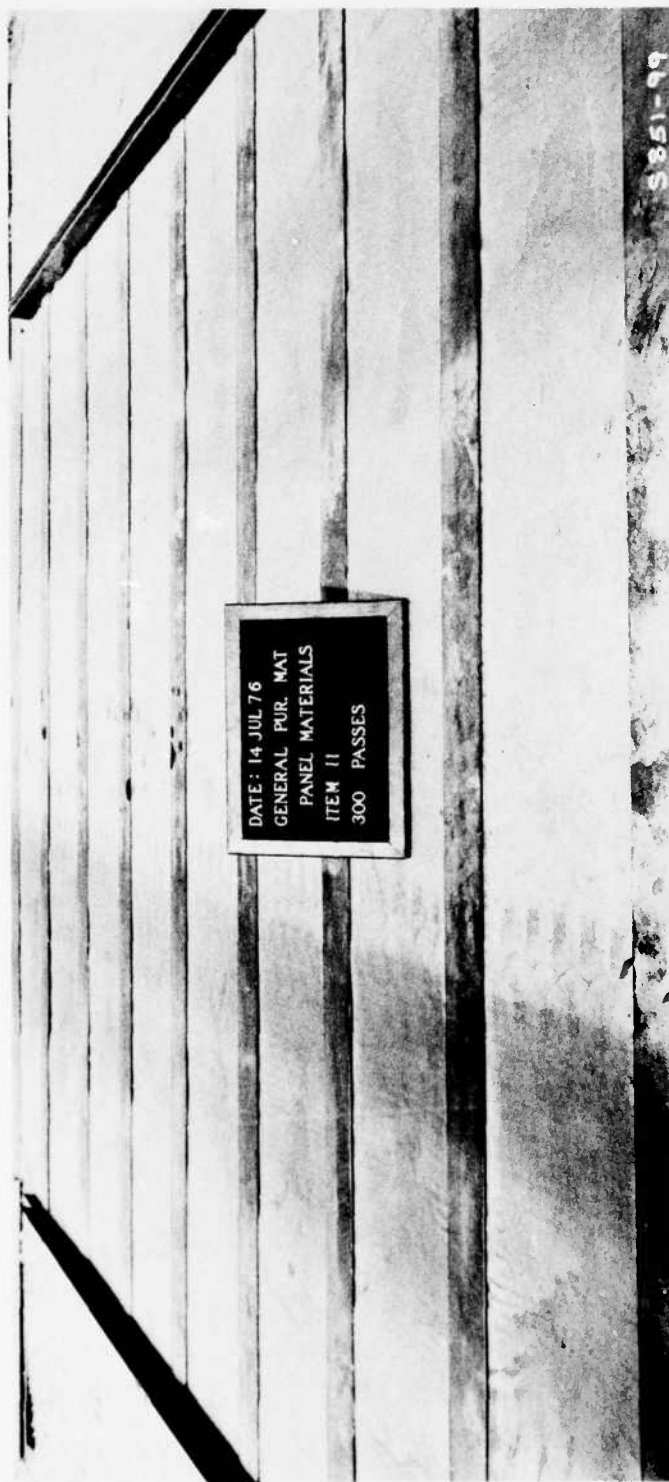
Photo 40. Failed Spur-Ecolite item 11 at 300 passes

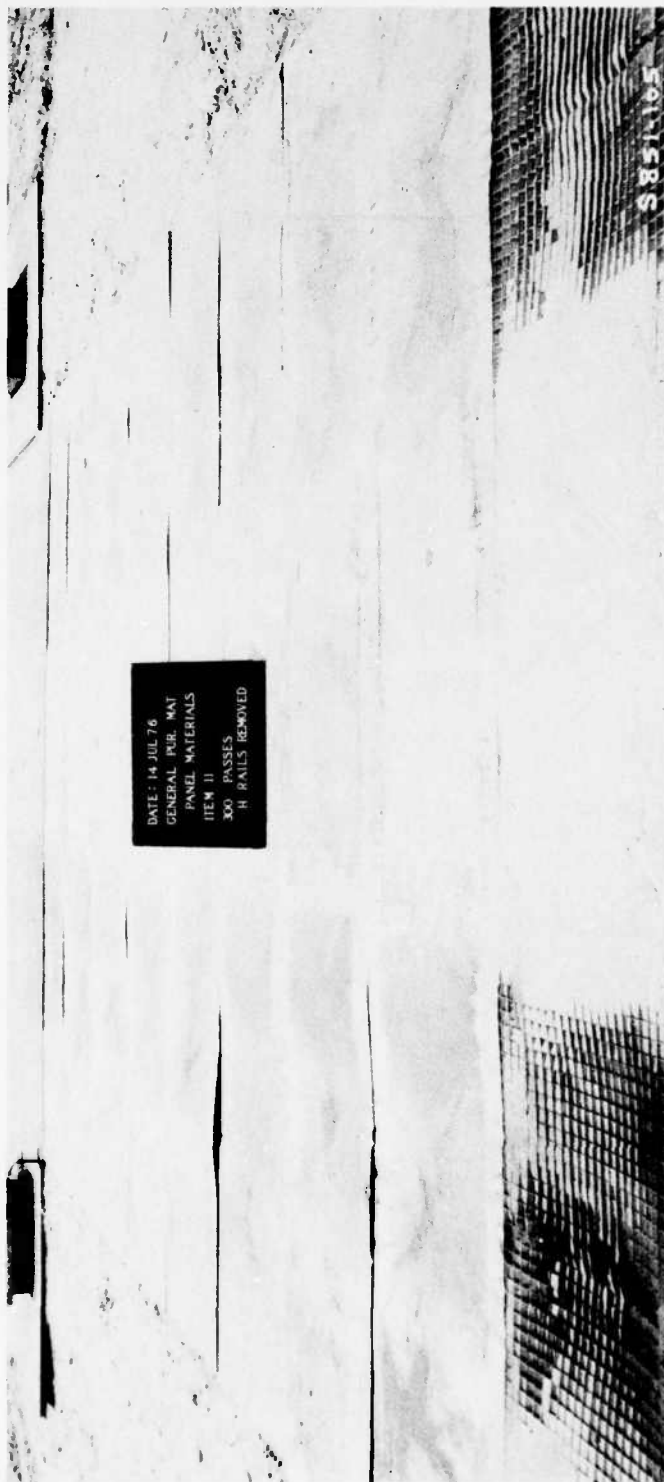
Photo 41. With H connectors removed, the top skins of the Spur-Ecolite sandwich panels are shown disbonded in wheel paths at 300 passes

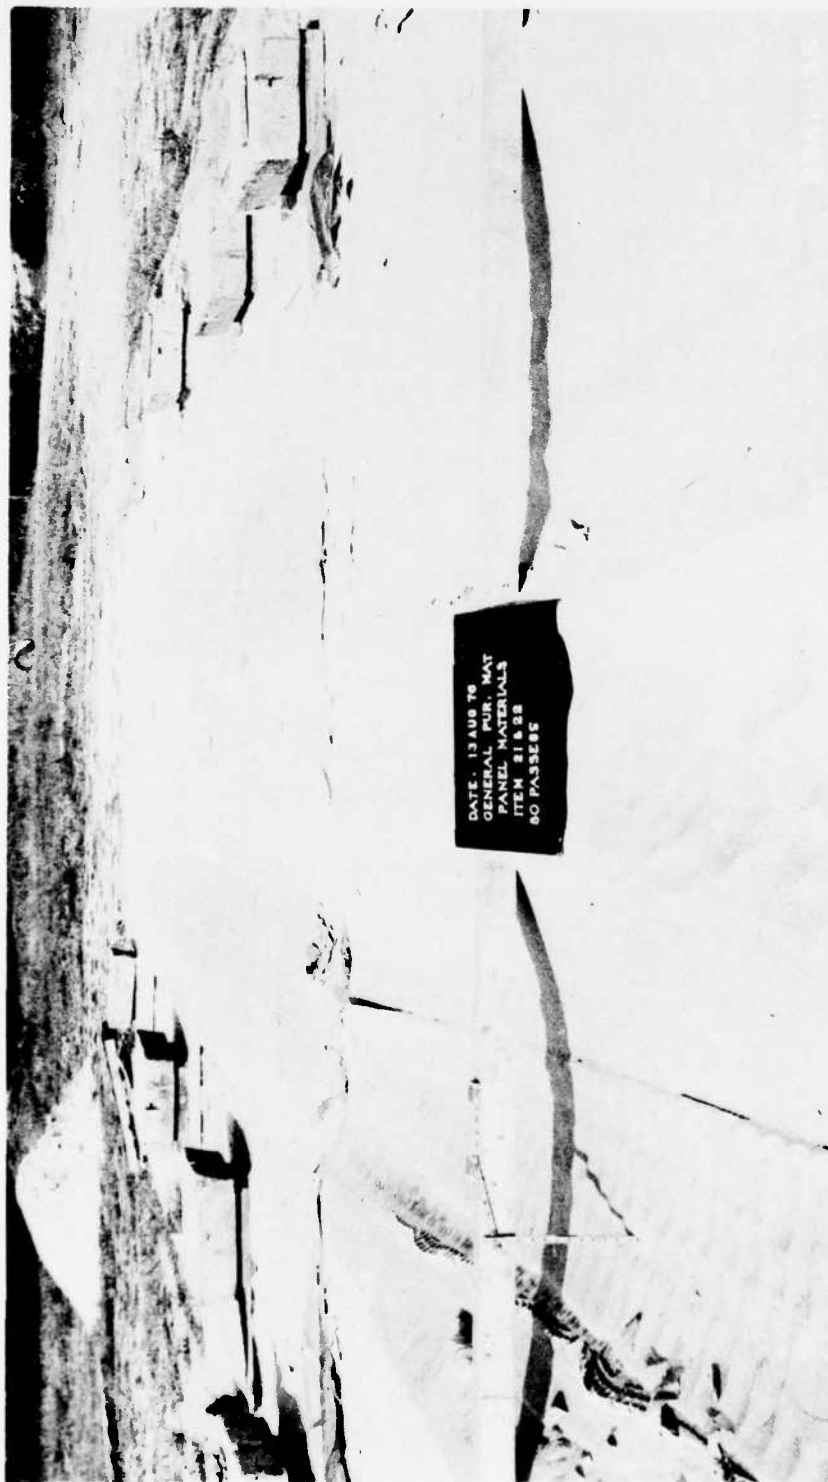
Photo 42. Items 21 and 22, Spur-Ecolite one-skin panels; failed item 21 (left) with skin up and unfailed item 22 (right) with skin down at 80 passes

58. A verification test was conducted on two Spur-Ecolite panels containing one skin, in which one panel was placed on sand with the skin up (item 21) and the other was placed with the skin down (item 22). The test vehicle was again used and two panels were placed on the sand in parallel lanes with the long axis in the direction of traffic, so that both panels could be trafficked simultaneously and thus easily compared. After 80 passes of the test vehicle, the panel with the skin up had failed. The core had disbonded from the skin, the core was split and broken, and the skin was wrinkled. However, after 80 passes on the panel with the skin down and the core openings filled with sand,

there was no disbondment and no apparent failure. Profile data (Plate 12) indicate that the panel with the skin down (item 22) embedded approximately one-half as much as the panel with the skin up (item 21) at an equal number of passes. Thus, as anticipated in initial studies of the design, the Spur-Ecolite panels with one skin perform better on sand if the skin is placed down and the open-square cells are filled with sand (Photo 42). This arrangement assures that the cells will be filled with sand which provides added strength to the core members.

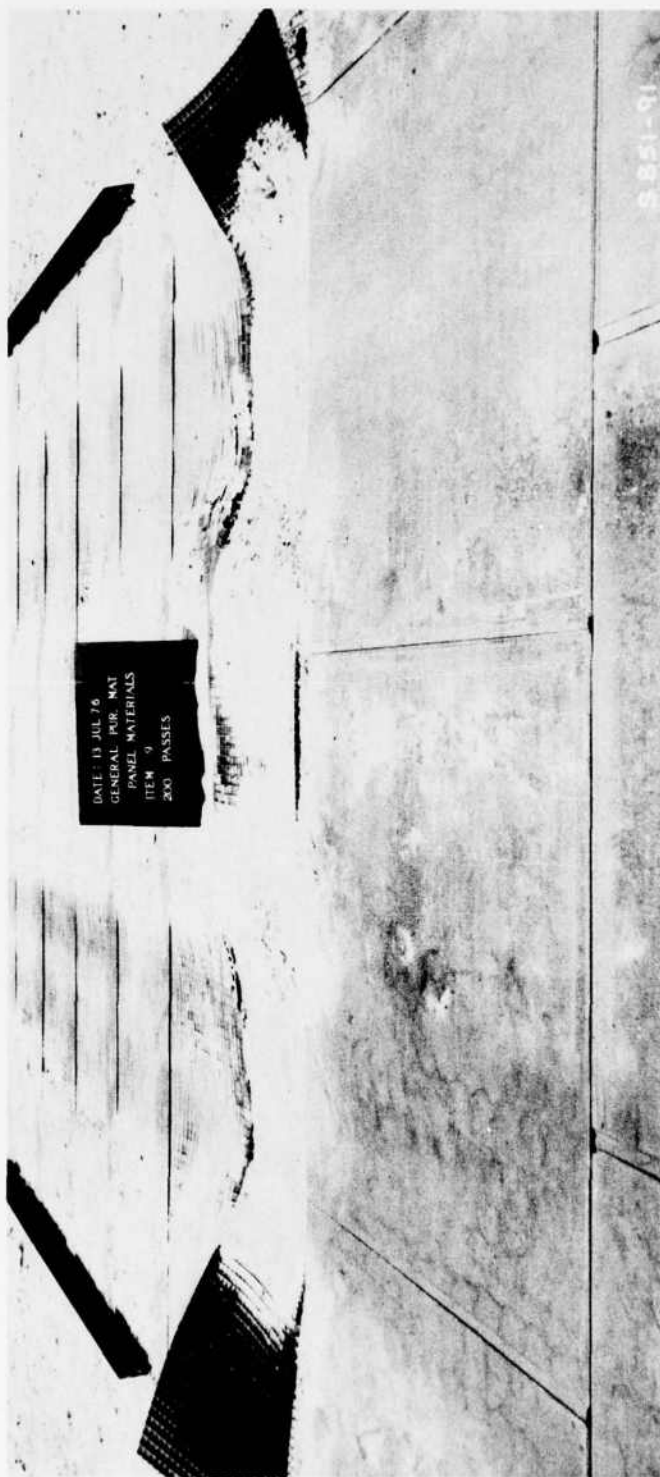
Photo 46. Ecolite 1- by 1-in. core, item 9, at 200 passes

67. In initial testing of the core, one of the 1-in. cores was placed on the dry sand, filled with sand, and trafficked with 400 passes of the test vehicle (item 9). During the first 200 passes, the core material performed satisfactorily in the wheel paths as the core continued to embed in the sand; however, the untrafficked areas tended to curl up and/or remain higher than adjacent material and cracks and breaks began to occur between these areas (Photo 46). After 300 passes, core crushing occurred as the sand escaped from the cells and the core was torn and flattened (Photo 47). For all practical purposes, the material was considered failed at this time as it would cause a hazard to vehicular traffic tires. The 1-in. grid core was placed on the sand again and the voids were filled with sand; however, the long axis of the core was oriented with the direction of traffic (Photo 48). In this test the test vehicle was allowed to drive up on the core from the sand; however, the drive wheels of the truck, in attempting to pull out of the immobilizing sand, caused severe breakage of the unprotected open-grid core material (Photo 49). Thus, the single thickness of the unsupported 1-in. core alone on the sand did not prove to be an adequate supporting material for the vehicle as loaded; hence, the 1/2-in. grid core in a single layer was not tested.

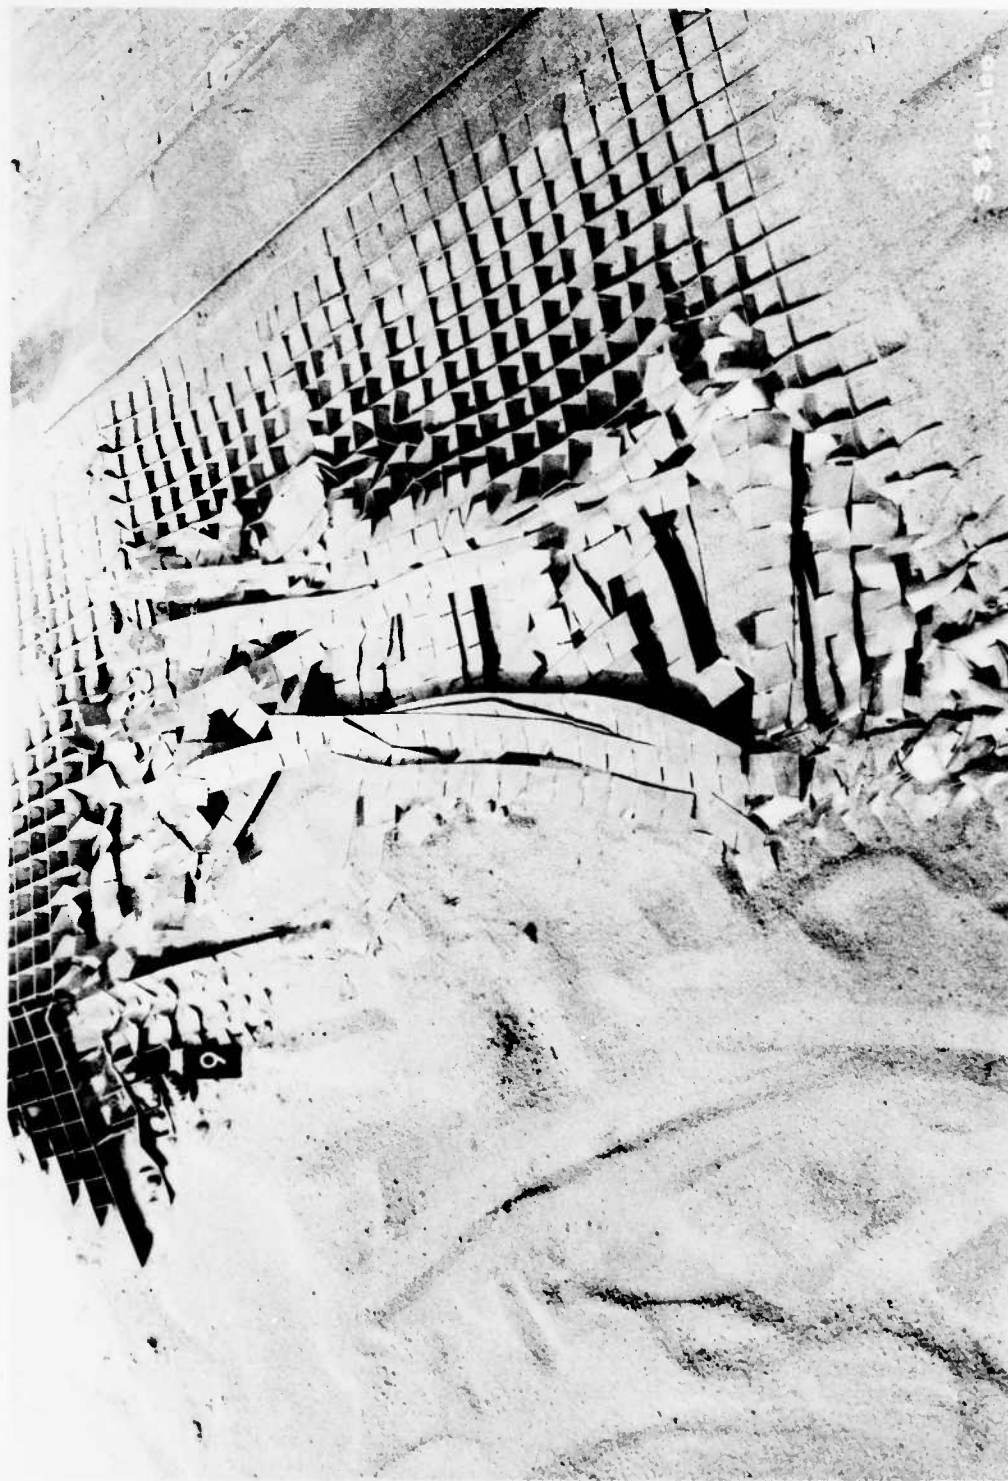
Photo 47. Ecolite 1- by 1-in. core, item 9, at 300 passes.
Note torn and flattened core ribbons

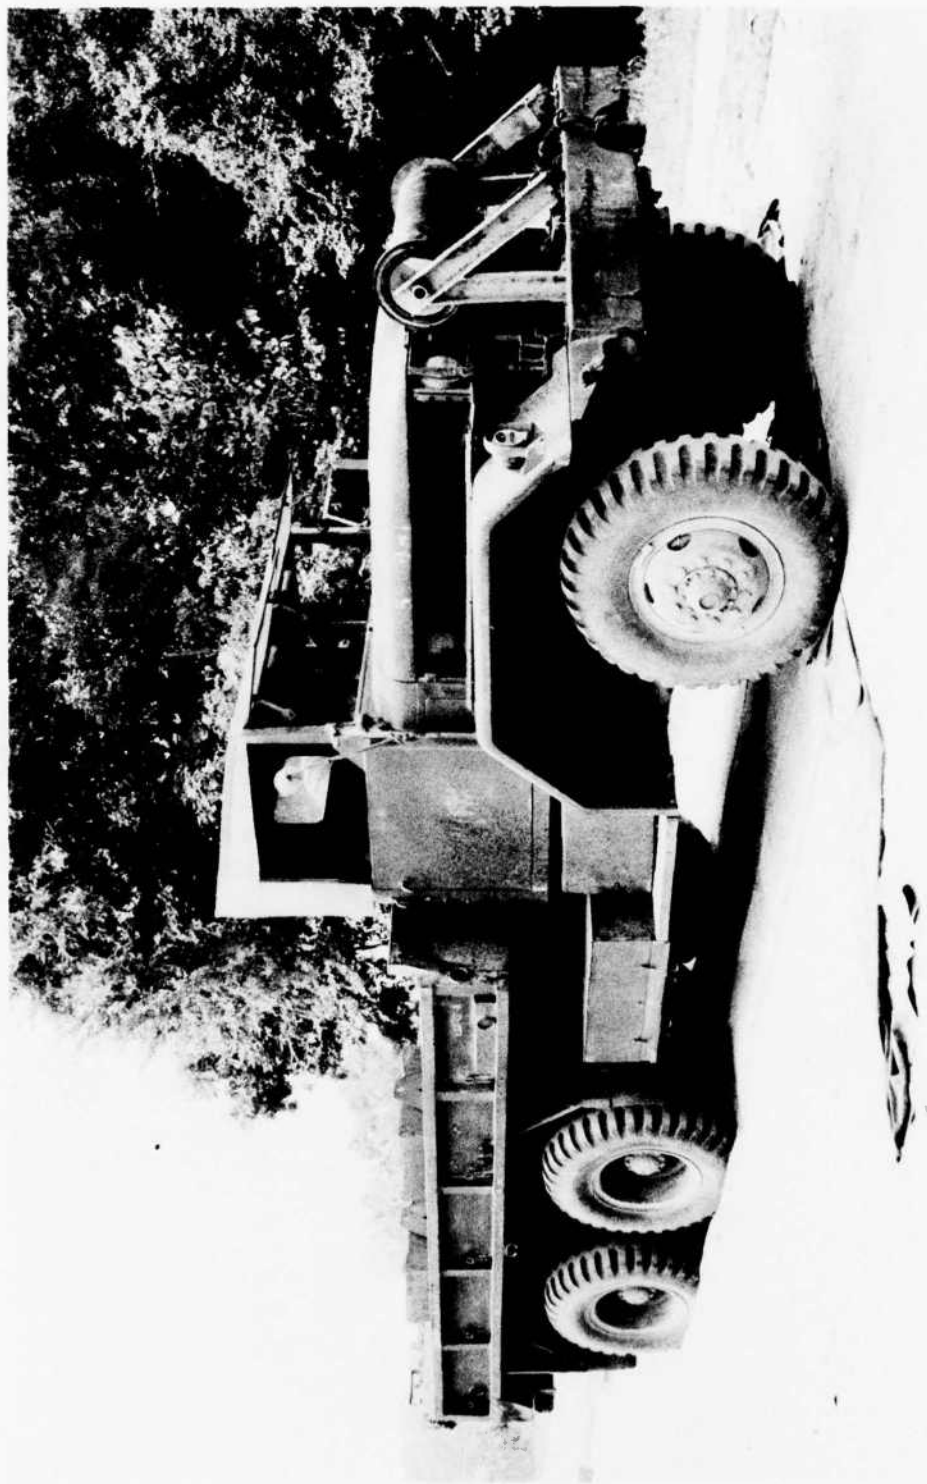
Photo 48. Ecolite 1- by 1-in. grid placed longitudinal to traffic
direction prior to traffic

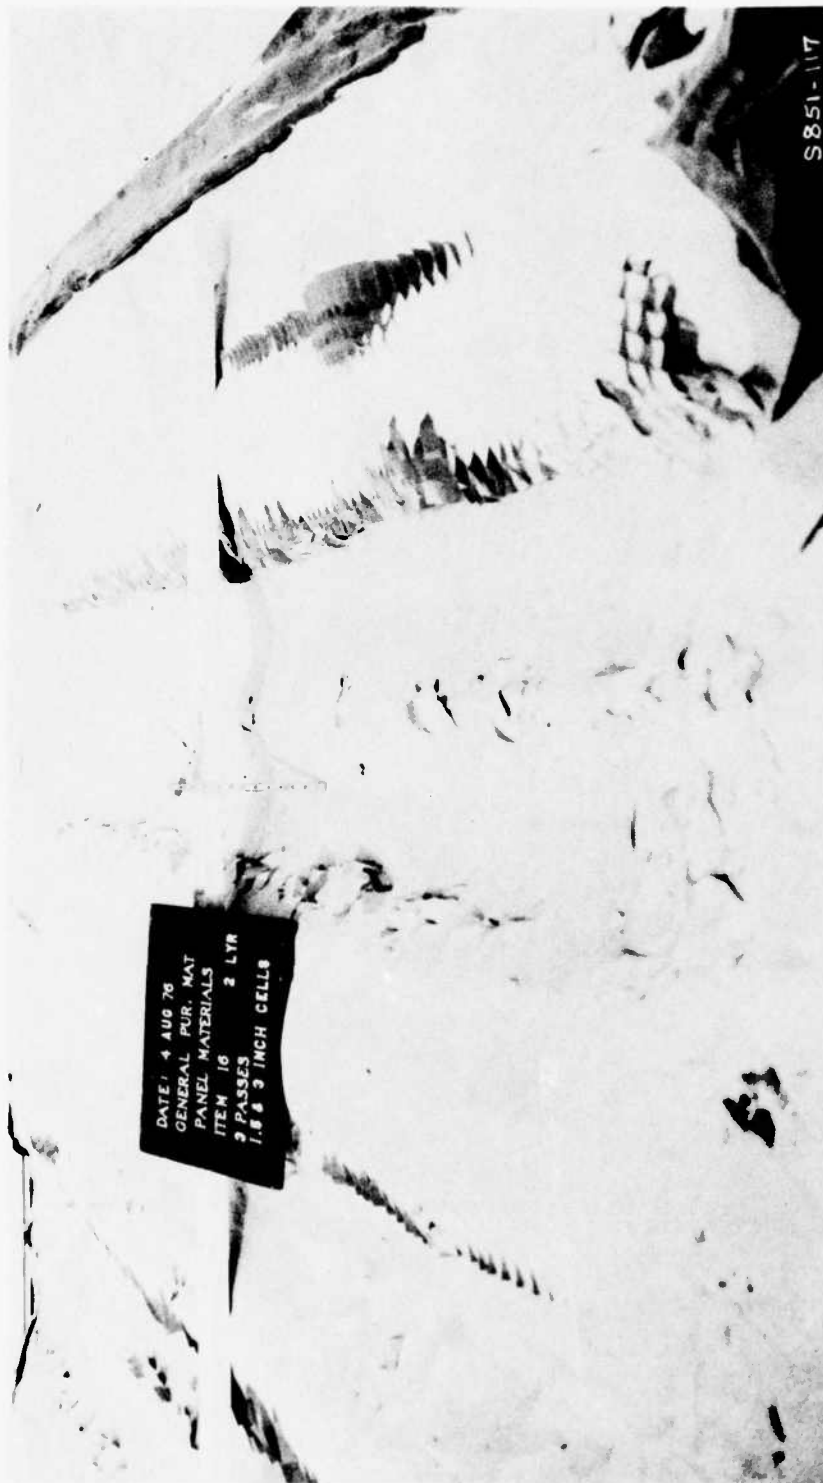
Photo 50. Hexcel paper honeycomb core, 1-1/2-in. cells, 2 in. thick,
in double layers, item 16 (north), after 3 passes

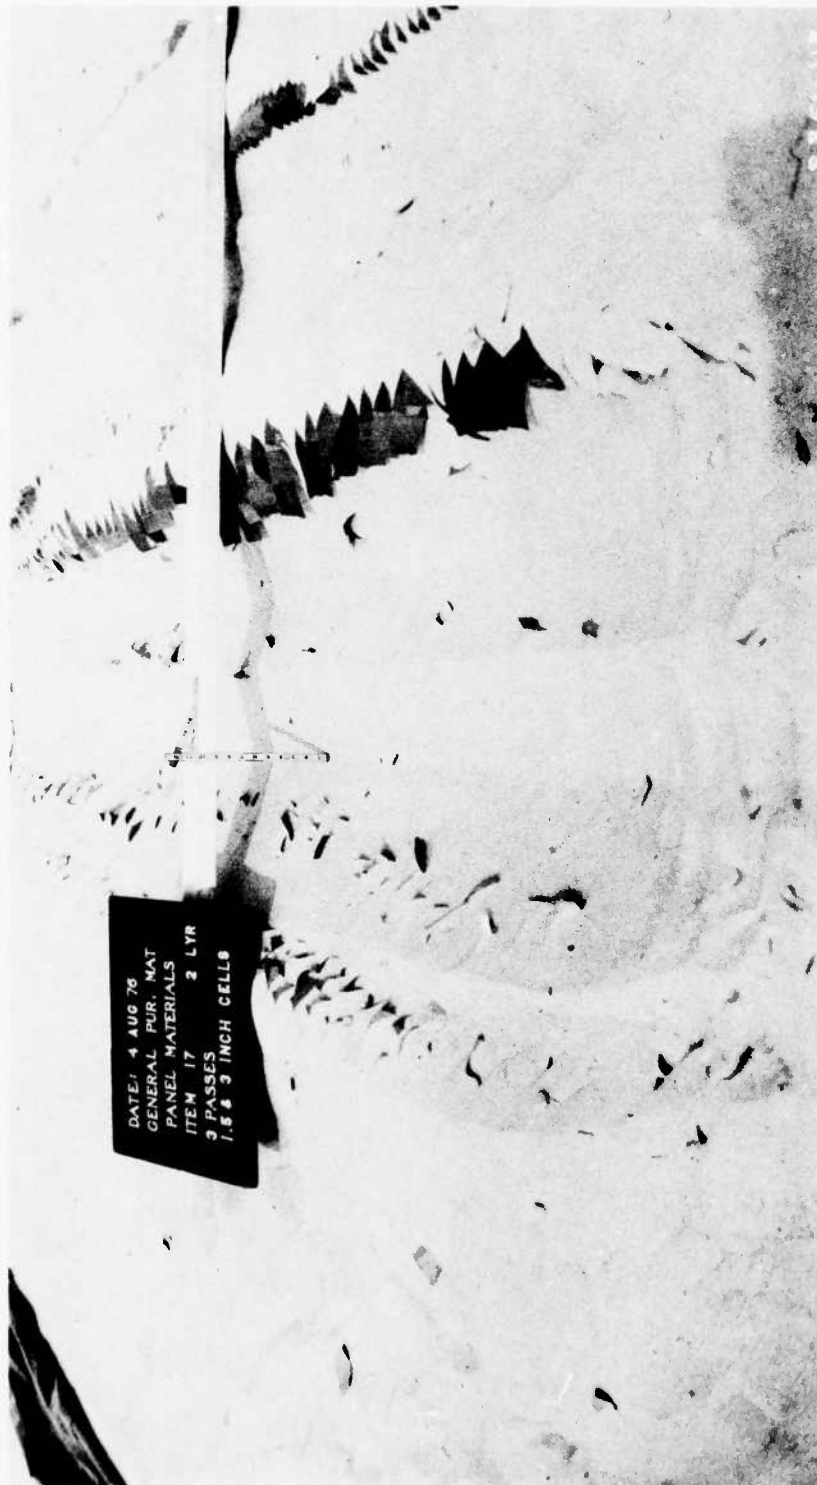
Photo 51. Hexcel paper honeycomb core, 3-in. cells, 2 in. thick, in double layers, item 17 (south), after 3 passes

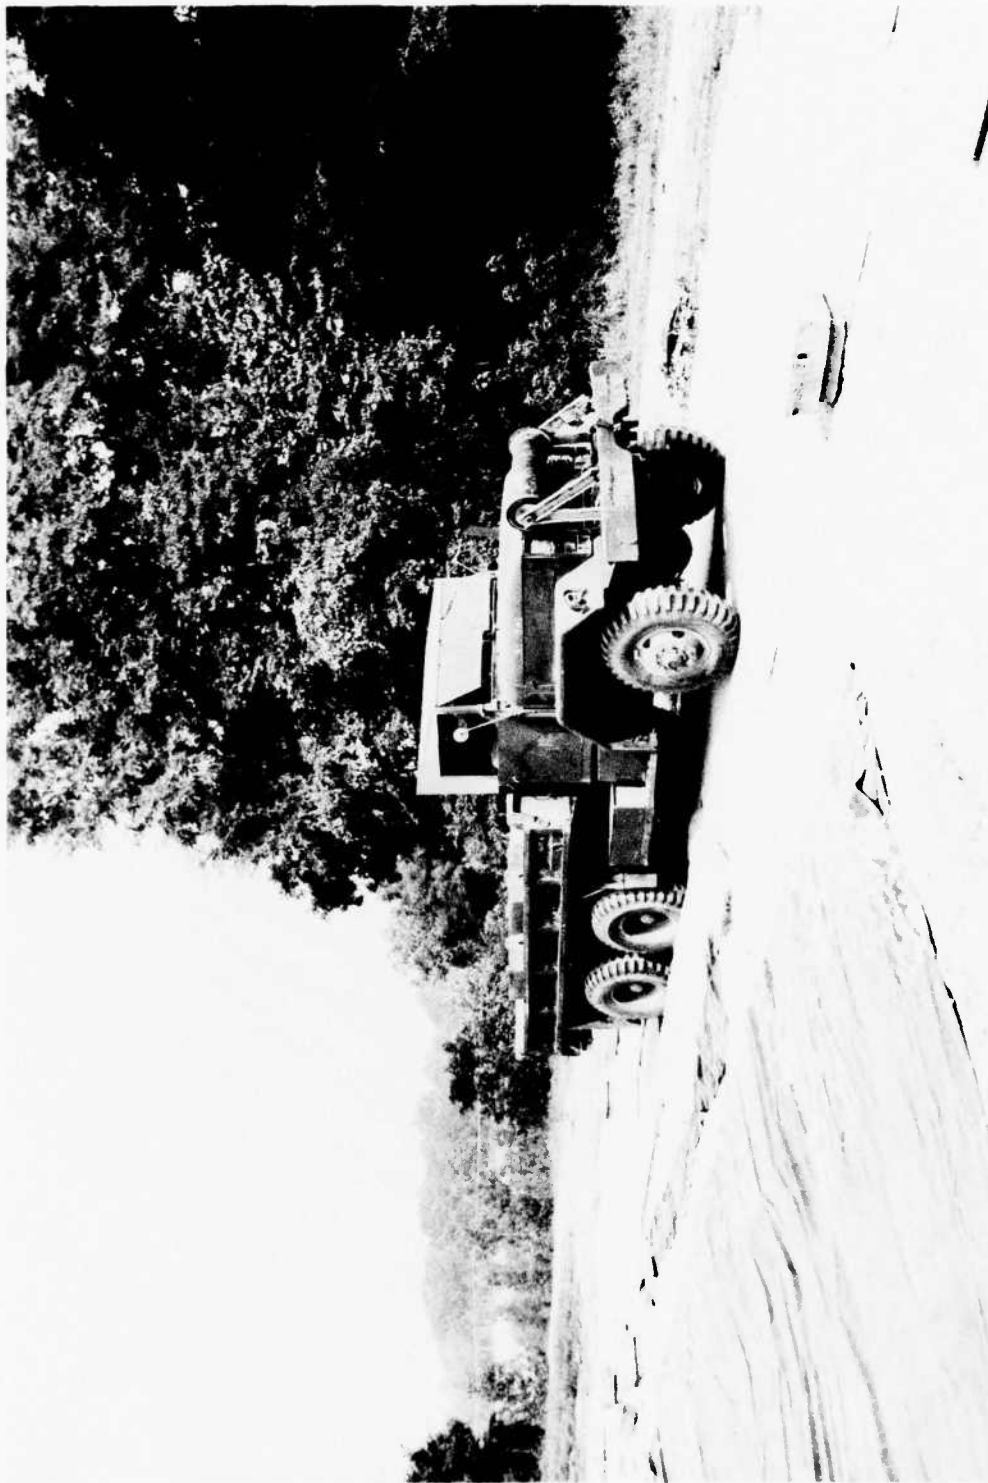
Photo 52. M54 truck, 40,000-lb gross load, on items 16 and 17, fourth pass

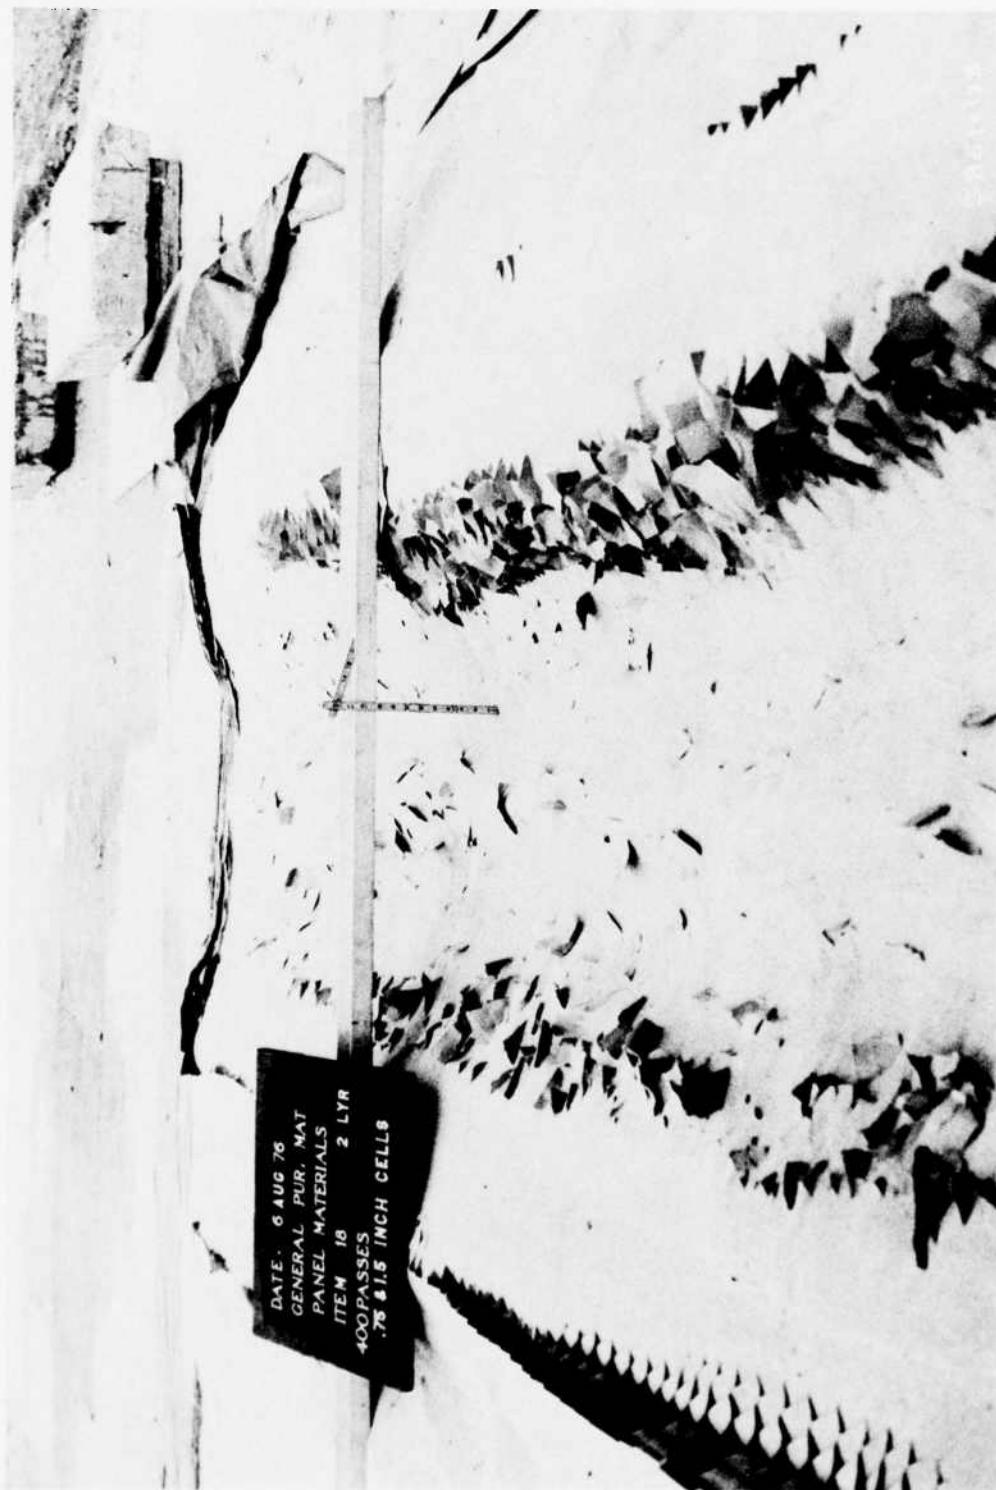
Photo 54. Hexcel paper honeycomb core, item 18, double layer of 1-1/2-in. cells, considered failed after 400 passes of mixed vehicular traffic

76. At this point (400 total passes), the 1-1/2-in. honeycomb material was considered failed due to disintegration of the material, and it was no longer considered suitable for traffic (Photo 54). In comparison, the 3/4-in. honeycomb was still performing satisfactorily and in excellent condition (Photo 55). Thus, matting was placed over the failed material and traffic was continued on the 3/4-in. material. After 500 total passes, there was some indication of failure along glue lines in the 3/4-in. cells in the top layer, although it was not critical at this time. However, after 1000 passes, four glue lines had failed as indicated by separations of the ribbons. The rut depth between the outside edges of the honeycomb and the center was as much as 4-1/2 in. However, this was due primarily to the curl up of the edges in the nontraffic areas. After a total of 2000 passes of the mixed traffic of the 1/2-ton pickup and the 1-1/2-ton truck, the rut depth had increased to approximately 9 in. on the 3/4-in. cell material, and both layers were turning up along the outside edges. The previously failed three or four bond lines tended to relieve some of the stresses in the honeycomb and these areas were still performing satisfactorily. Except for the outside edges which had not been trafficked and were curling up and losing the sand in the voids, the core was performing satisfactorily (Photo 56). Trafficking was discontinued at this time with the 1-1/2-ton truck. Profile data (Plate 16) indicate that the honeycomb had continued to embed in the sand to a maximum of 6-3/4 in. or for an average of approximately 5 in. For information purposes, eight additional passes of the original 5-ton truck with a 40,000-lb payload were applied to the section, and the honeycomb showed no change or additional distress due to this loading. Additional traffic was not applied as examination of both layers of the honeycomb was desired. The examination revealed that the bottom layer was contoured to the top and that breaks were similar in both layers but to a lesser degree in the bottom layer.

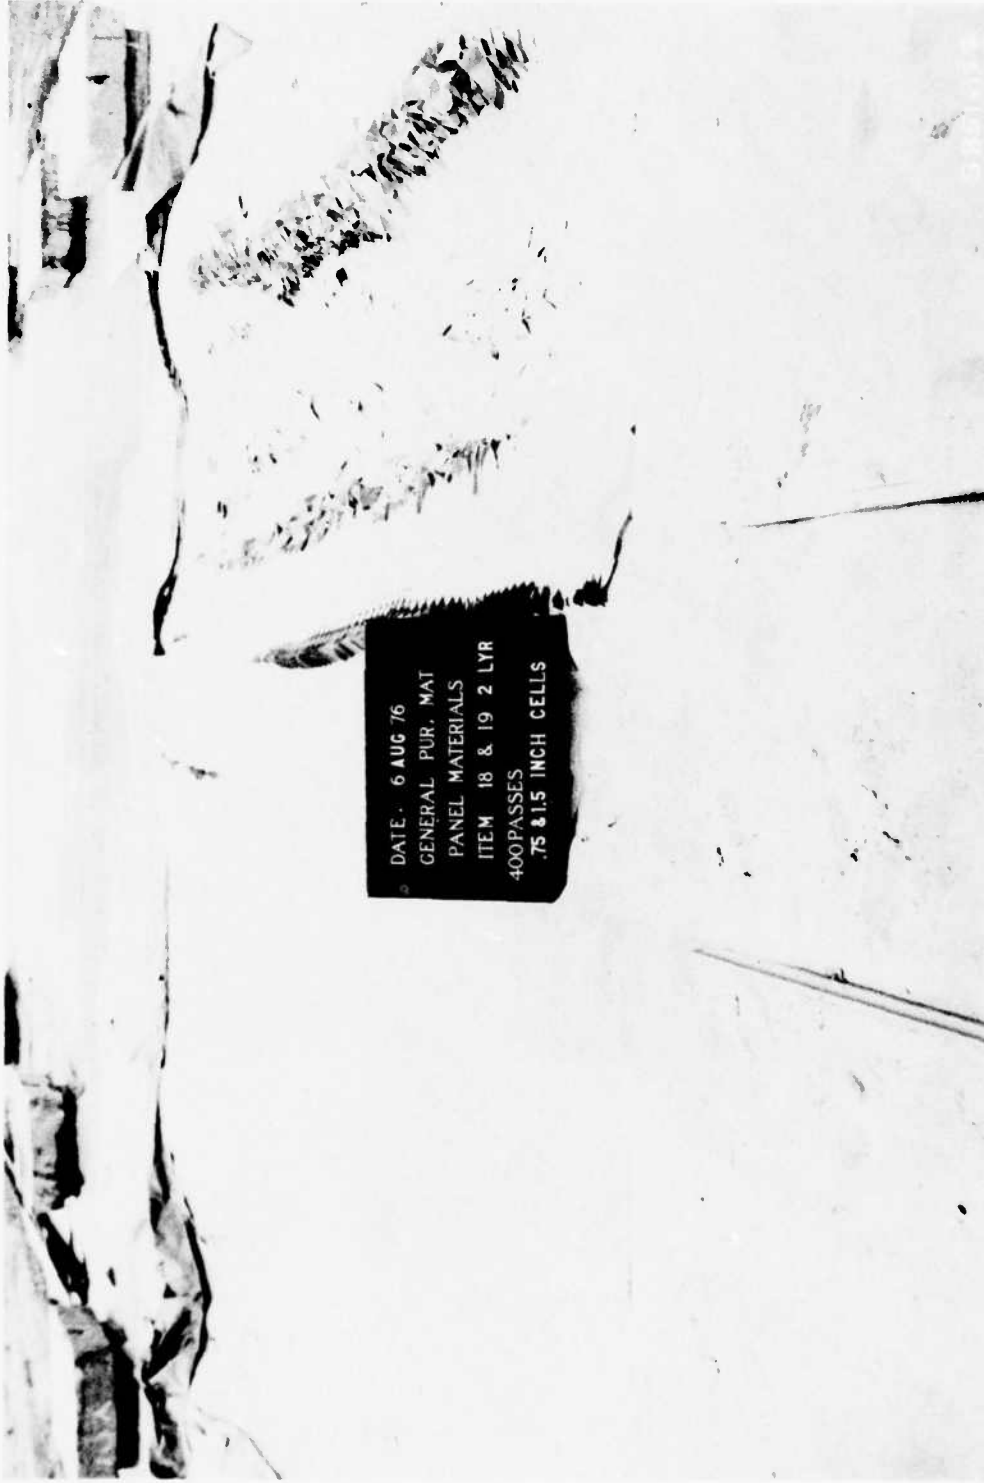
Photo 55. Hexcel paper honeycomb core, item 19 (left), double layer of 3/4-in. cells, in good condition after 400 passes of mixed vehicular traffic

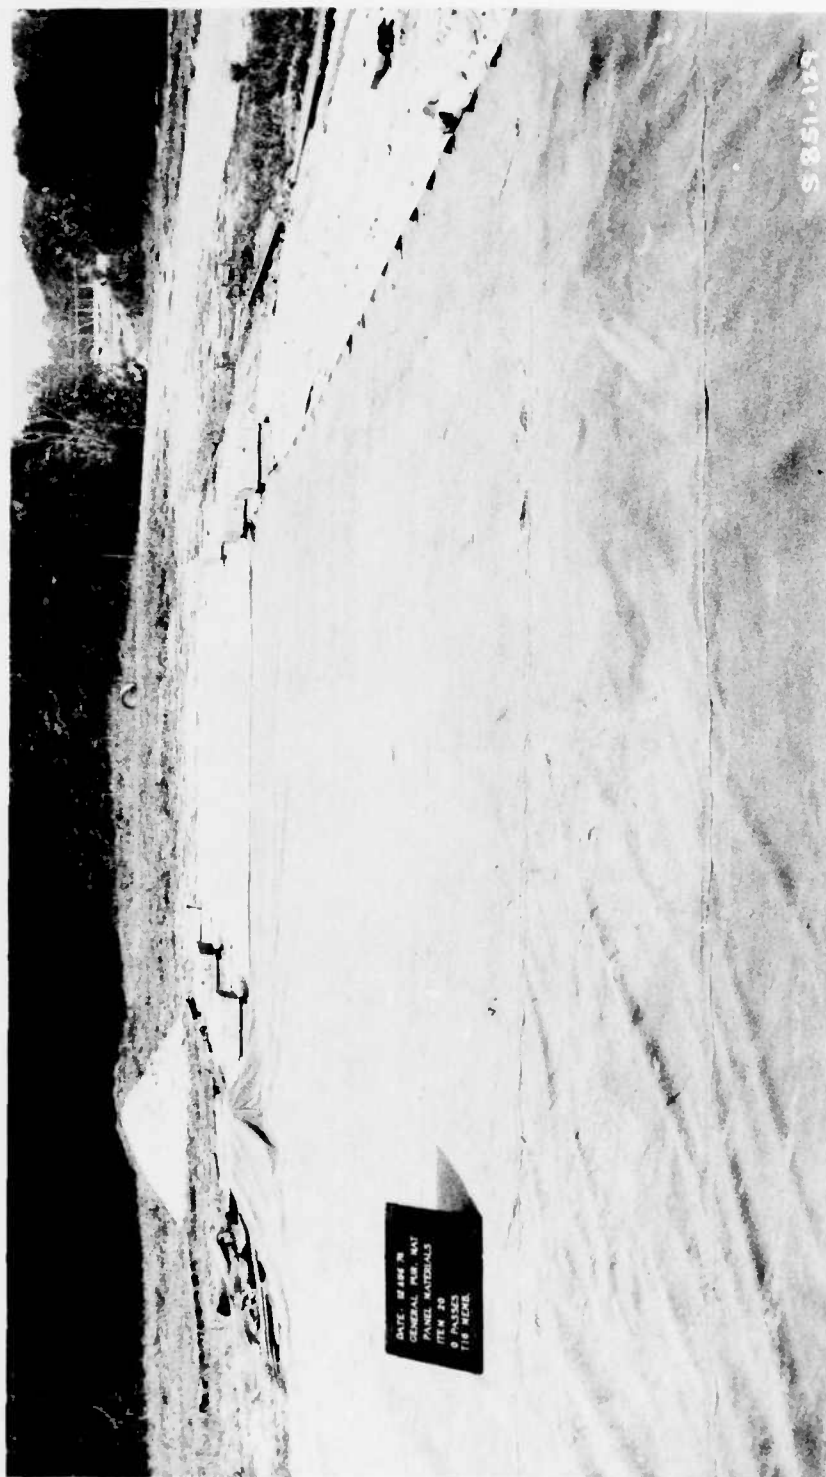
Photo 59. Item 20, T16 membrane on dry loose sand prior to traffic

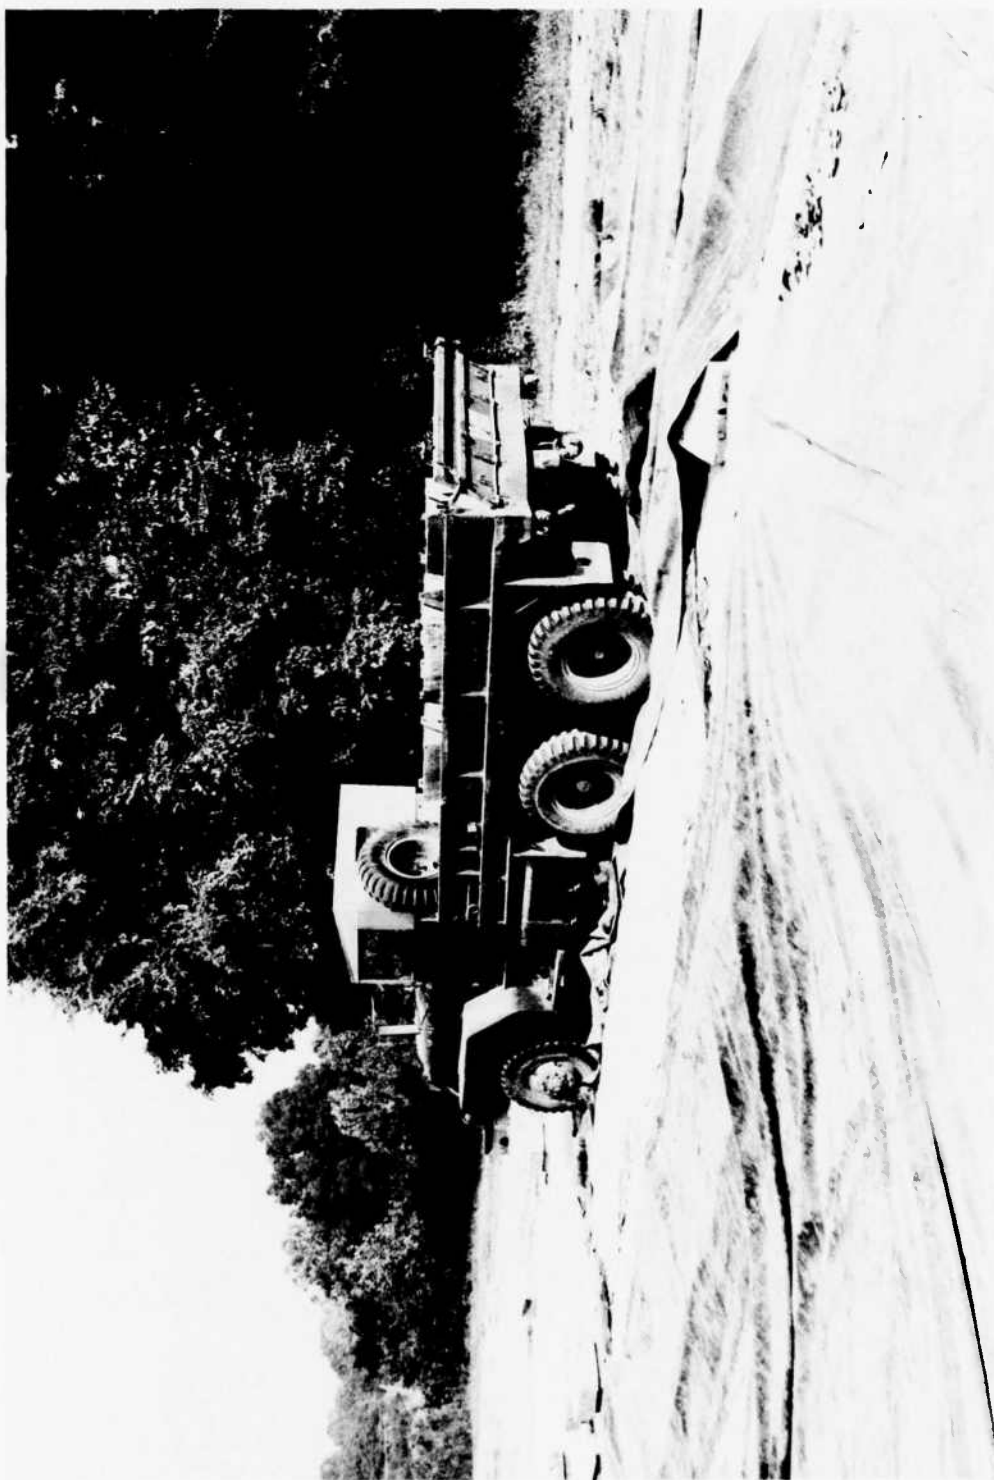
Photo 61. M54 truck on WX18 membrane at 8 passes. Note that membrane edge has been pulled toward the ruts by action of the wheels
